# SAND SPRINGS

## COMPASS INDUSTRIES SUPERFUND SITE

**2012**

## ANNUAL OPERATION AND MAINTENANCE REPORT

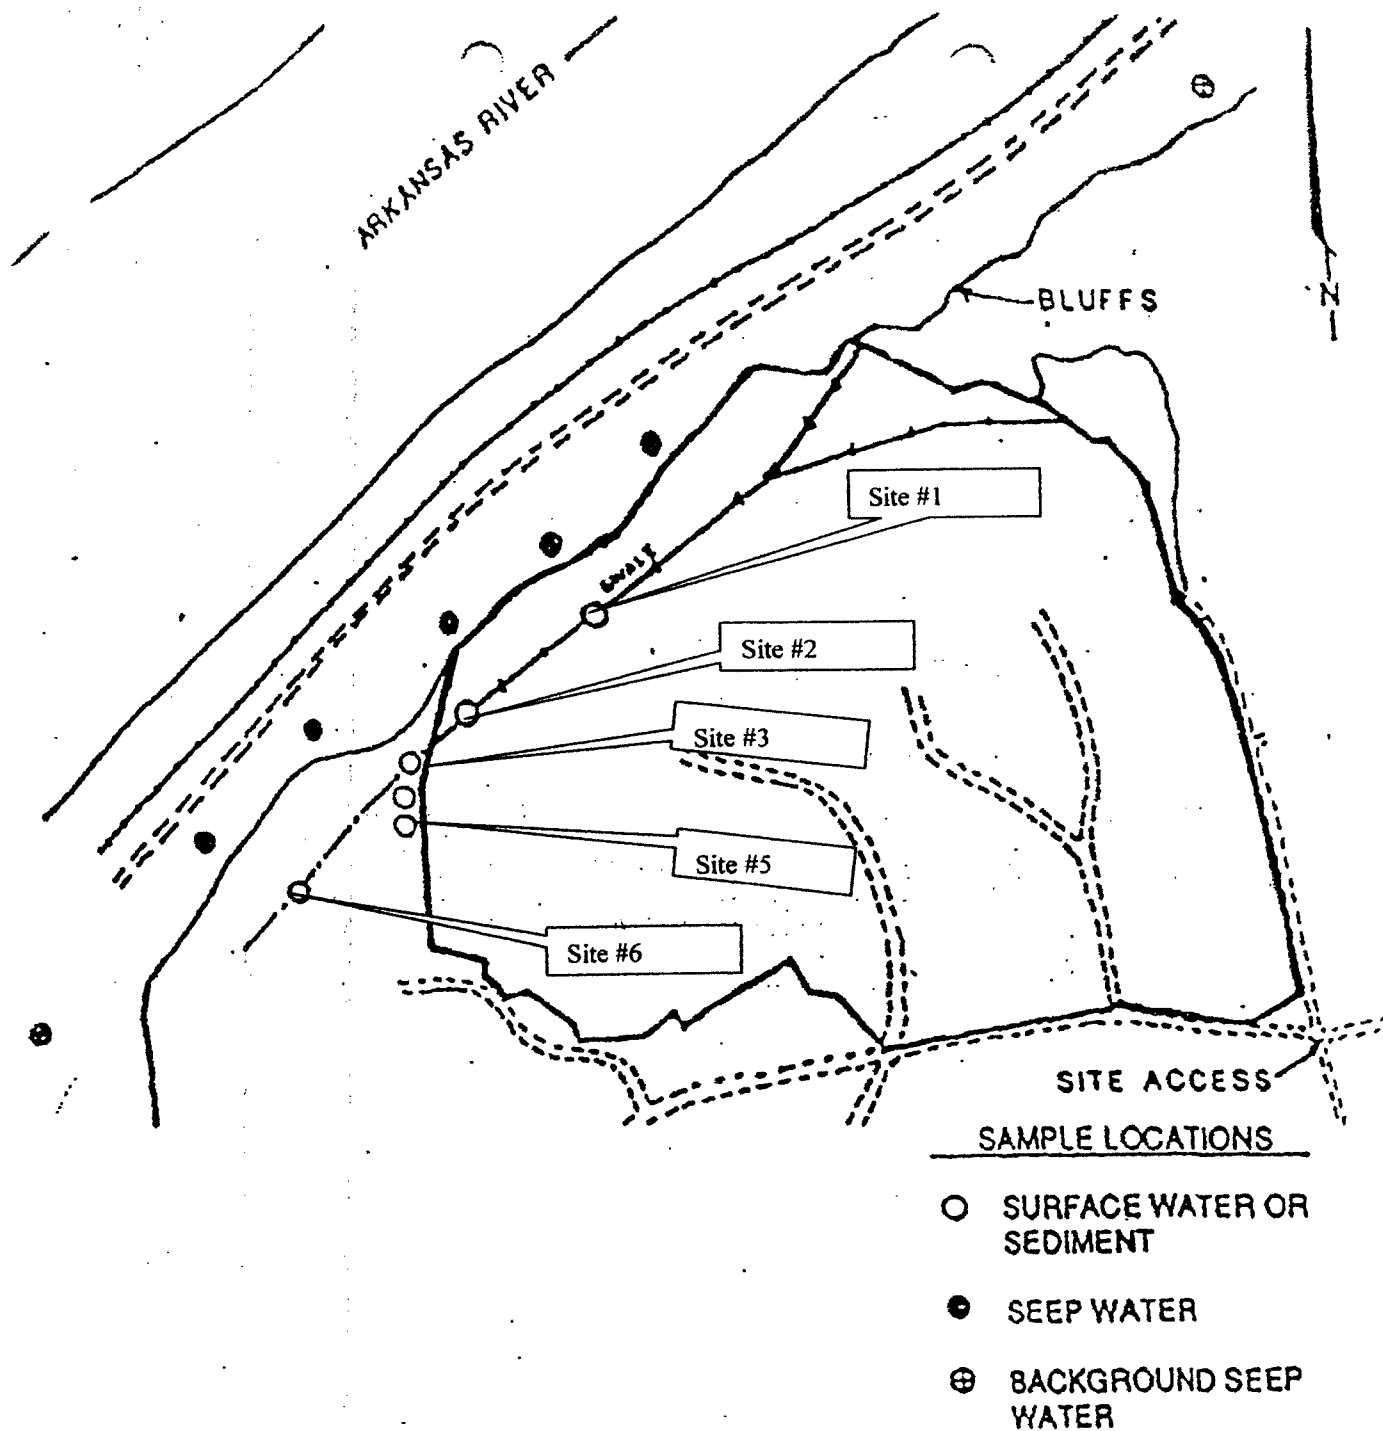
FIGURE 1  
SAMPLE PROGRAM LOCATION

NOTE: The location of the monitoring points is approximate and will be limited to: 5 seep samples  
2 background samples

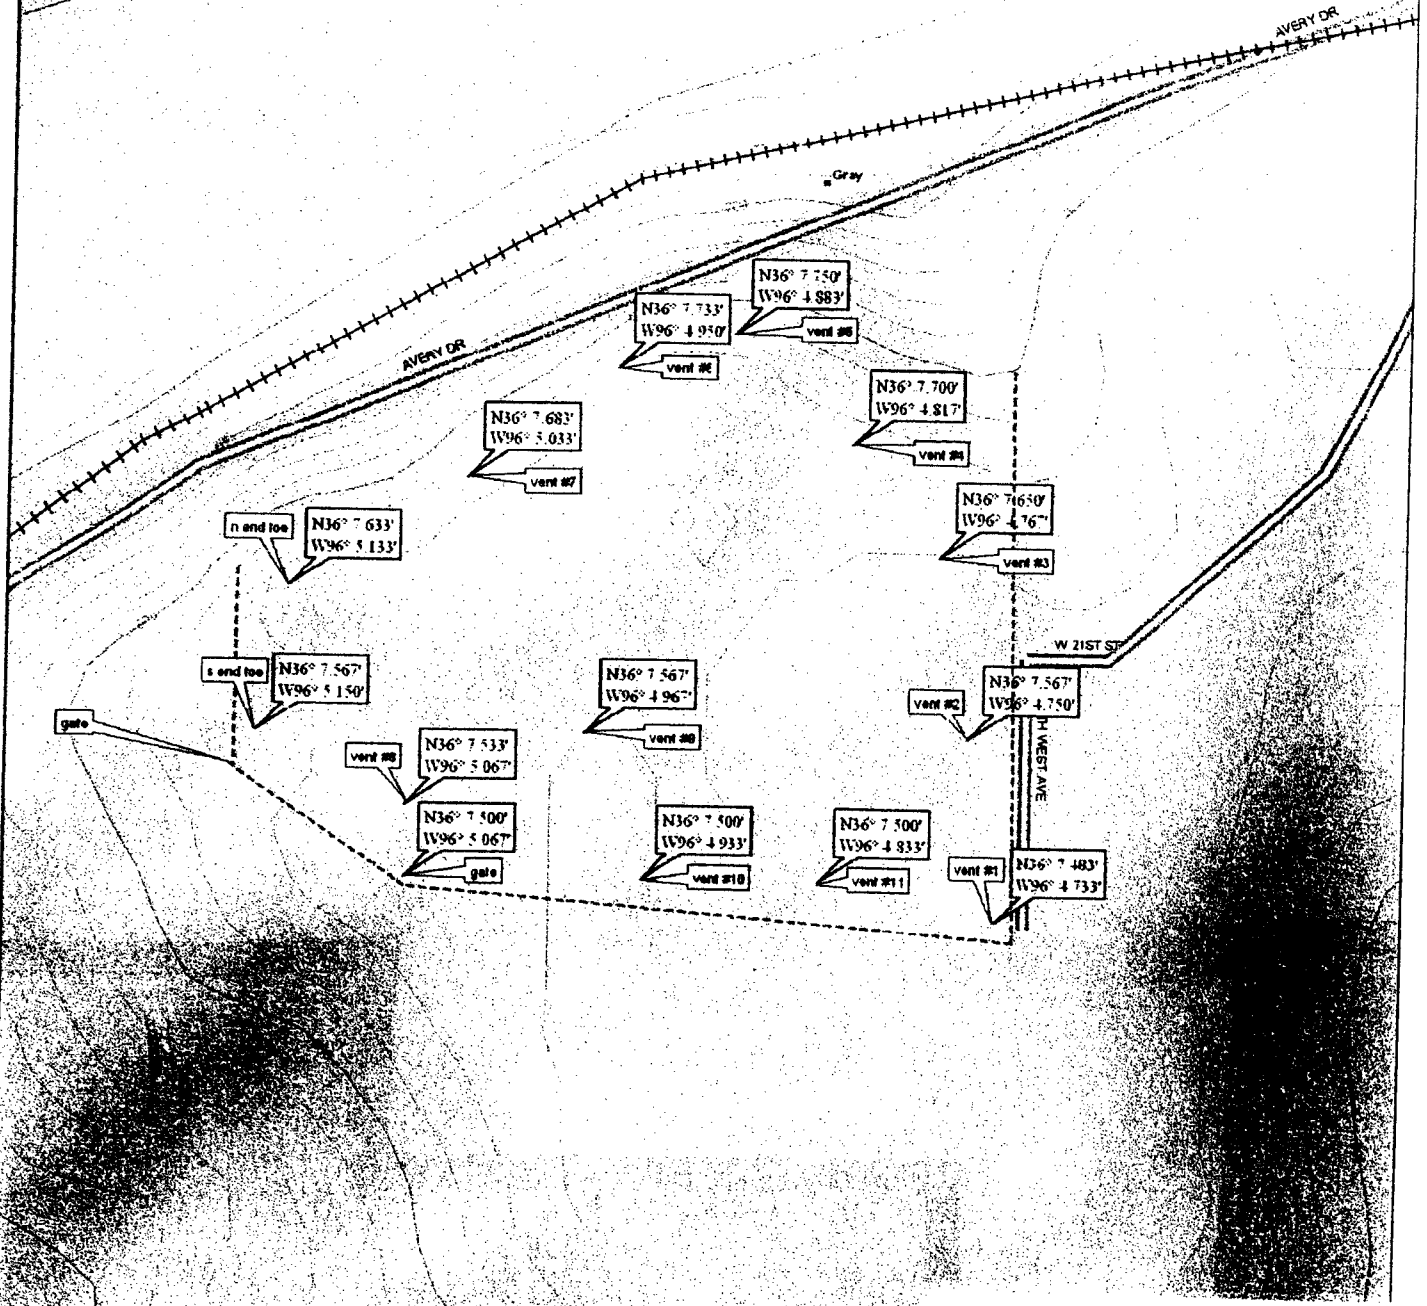
ATTACHMENT 1A

Stelle & Associates, Inc provided service to locate, inspect, and record sample vent emission tests at the eleven (11) vents along the perimeter of the site cap (Figure 1A) on **July 31, 2012 and December 4, 2012**. The vents were tested utilizing a MiniRea 2000 Organic Vapor Analyzer (OVA) with Photo-Ionization Detector (PID). Prior to conducting the tests the OVA was calibrated with a 100ppm isobutylene span gas. In the July 2012 and December 2012 sampling vent emissions were checked for **Methane** using a Thermo Scientific TVA 1000 Flame-Ionization Detector (FID). The FID was calibrated for **Methane** and fitted with a carbon filter on the intake, in order for readings to be specific for **Methane** on each sampling event. An upwind background reading of the **Methane** level was noted at each vent. A TSI Velocichcek 8340 was used to measure the flow rate of the emissions from each vent on each sampling event. **The results from each meter are summarized on the tables attached to the Stelle & Associates, Inc. reports for the subject July 31, 2012 and December 4, 2012 Sampling Events. See Attachments (Figures 2 and 2A).**
